Project Description

Stream: Swan Creek (QHEI at South Ave = 44.8 (2017))

PROJECT LOCATION

OPINION OF PROBABLE CONSTRUCTION COST TETRA TECH

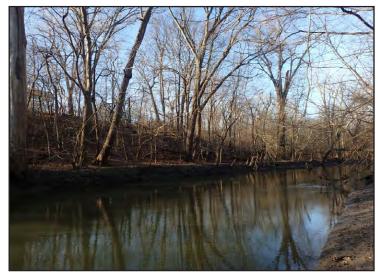
Swan Creek flows from west to east through the project site. With the exception of a few areas where the slope of the bank up to Arlington Avenue is very steep, the banks are generally shallow and do not exhibit signs of erosion. The stream does not appear to be channelized. Existing in-stream cover is moderate to sparse and is predominantly composed of woody debris and root wads. A stretch of approximately 750 linear feet of Swan Creek in the middle of the site is a uniform glide habitat with limited in-stream cover.

Glide habitat in the middle of the site

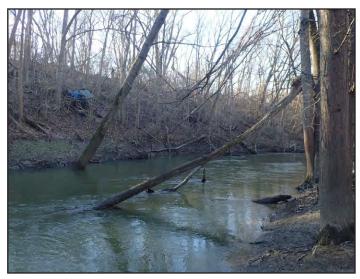
Steep slope in the southwest portion of the site

There are a few characteristics of the site that make restoration challenging. As previously mentioned, the proximity of Arlington Avenue to the southern bank of the stream has resulted in very steep banks that are exhibiting signs of erosion. Due to the physical conditions in this area, the restoration footprint is restricted, and consequently the potential restoration techniques available are limited. A restoration to return the stream to a more natural morphology with less steep banks along the southern bank would require large-scale tree clearing and impacts to Arlington Avenue.

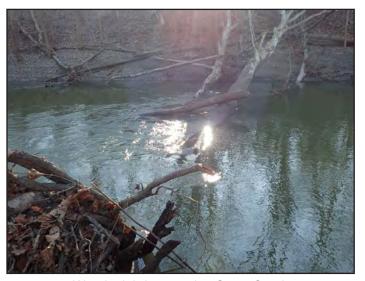
Woody debris spanning Swan Creek

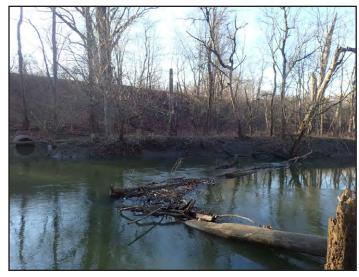
Storm sewer outfall in the middle of the site (left) and minor logjam catching litter

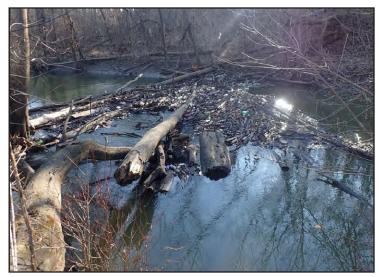
A large floodplain wetland exists on the north side of the stream and several smaller riparian benches with wetland vegetation are located on the south side of Swan Creek. Trash and floating debris were observed behind a few logjams during the site visit in early January 2020.

Logjam collecting trash and litter

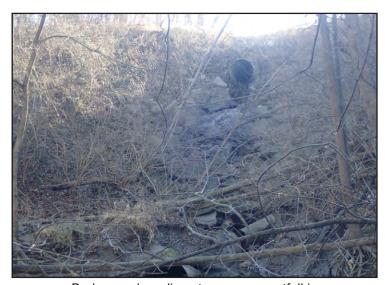
Three UTMC storm sewer outfalls are located along Swan Creek within the project site. A leak in the western-most outfall that has since been remedied resulted in a segment of the pipe failing and the bank below the outfall eroding into the stream. Large pieces of concrete were placed in the resulting empty space to prevent further erosion. However, longterm stability of the bank and riparian habitat could be improved in the area.

Broken and eroding storm sewer outfall in the western portion of the site
